Seeing is Believing!

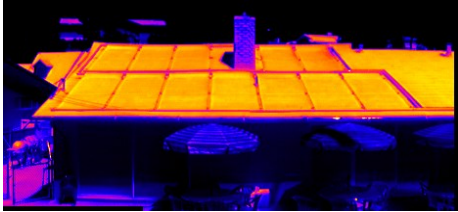
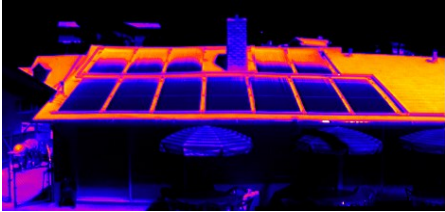
Untouched infrared photos show water (blue) filling the panels from bottom to top, providing even flow and maximum heating performance without hot or cold spots.

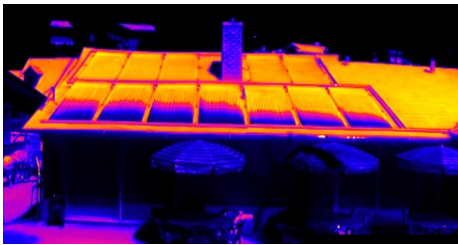
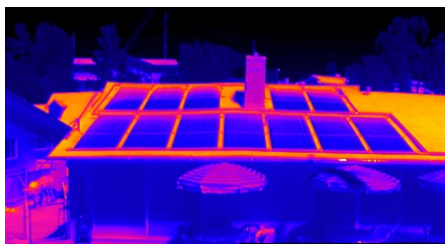
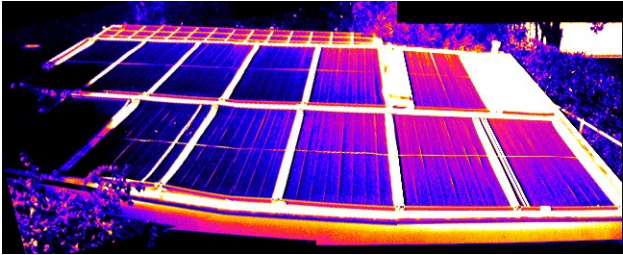
Untouched infrared photos show water (blue) inside a fully filled competitive system. Uneven flow leaves hot spots (red) that reduce heating performance.
